Proposal for Diagnostic Monitoring of the South Wall of the Nave at La Vieja Misión San Antonio, Texas

December 17, 2018

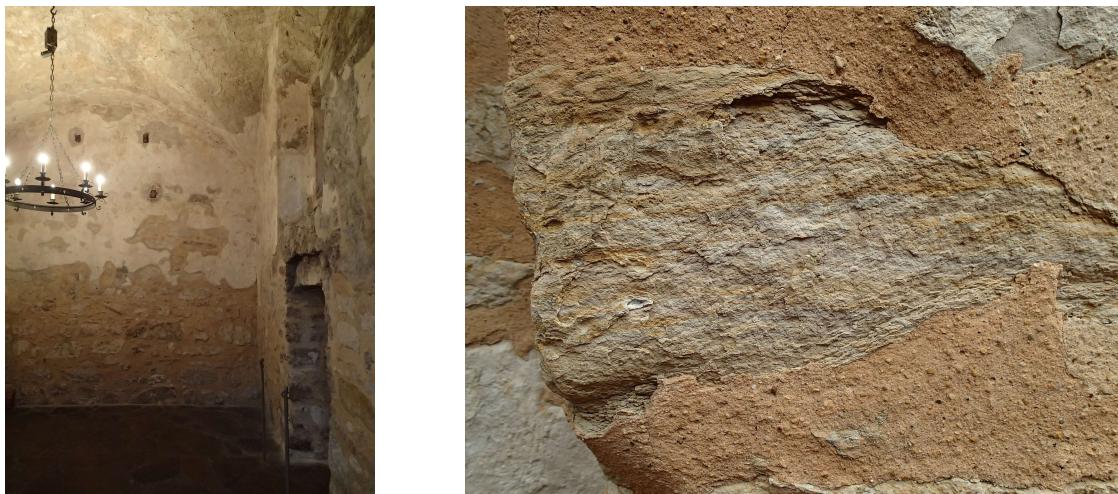
Figure 4: (left) Evidence of rising damp and loss of plaster on the interior wall. (right) Deterioration of stone through delamination

The plaster is falling off the bottom half of the interior side of the south wall (Figure 4). According to a report generated by a stone conservator, the stone is actively deteriorating through delamination, and it is visibly recessed below the mortar.²² On the exterior of the wall, there is a dark staining along the concrete cap of the pilaster, which could be a result of biological growth and/or dark gypsum.

The loss of plaster on the interior wall is possibly the result of subflorescence, which is caused by soluble salts (sulphates, nitrates, and chlorides) from the ground being transported through the wall as ions in water and recrystallizing beneath the plaster surface upon drying.²³ The salts could be recrystallizing behind the plaster (subflorescence) causing it to separate from the stone and mortar or the salts could be forming within the plaster causing the plaster to disintegrate. When considering the location of the plaster damage, it is feasible that the losses are correlated to the rising damp from water in the soil. The recrystallization can cause internal fractures within the matrix of the stone and mortar as well. The caretakers of the chapel installed an asphaltum barrier below the concrete slabs of the interior floor and waxed the surface of the floor as an attempt to prevent soluble salts from efflorescing on the floor of the chapel (Henry, pers. comm.). These barriers could result in an increase in salts within the wall as rising damp below the floor is forced to find another way around the sealed surface of the floor.

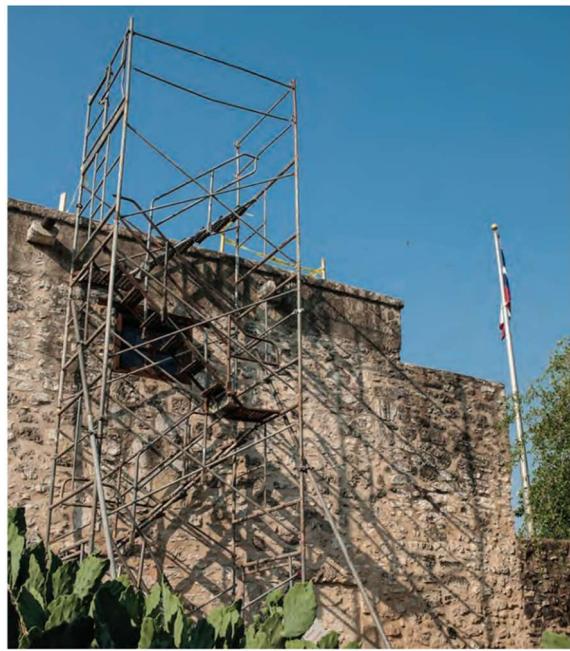
Figure 6: 2012 repairs of the roof.

In 2012, contractors were hired to repair the roof's structural deficiencies and prevent further moisture infiltration (Figure 6).³⁴ It is unclear how this was repaired, but it is possible that there may have been cracks as a result of the lack of expansion joints.³⁵ The lead roof will expand and contract in hot and cold weather and if there is nowhere for the lead to move it can cause splitting. It is also possible that there could be cracking in the concrete due to its poor working properties under tension. Mastic is coating the upper surface of the concrete parapets but to avoid a visual disturbance, it does not extend over the corners, which provides access points for rain water into the wall. Since the roof has a lead coating, it is a great conductor of heat and may impact interior temperature. The radiation of heat from the roof is evidenced in the poor performance of the HVAC condensers on the roof that may be attributed to vapor lock from the heat or overflow from rain water.³⁶

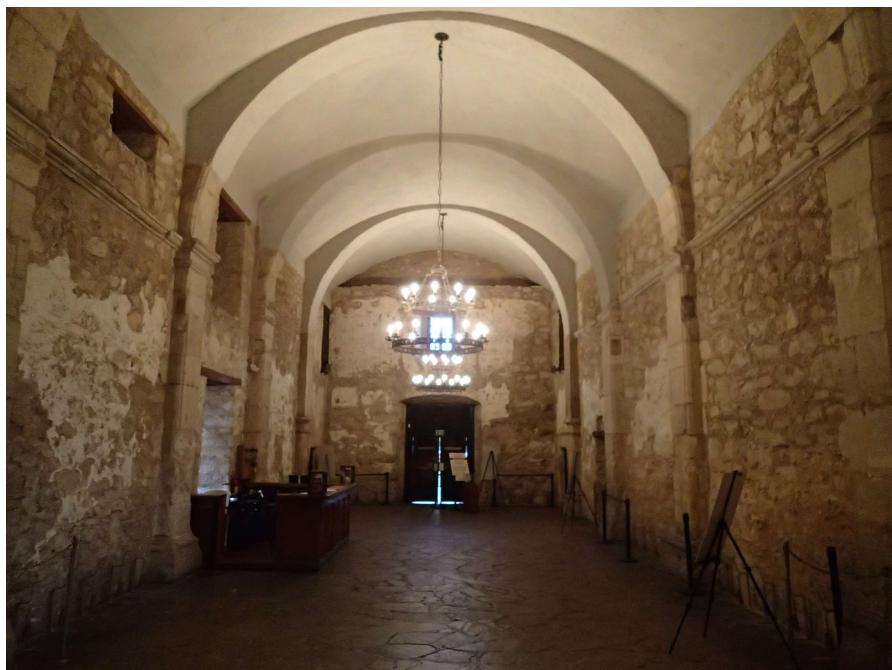
Figure 7: Image of the nave interior that shows large gaps in the door frame.

Because of the high heat during summer months in Texas and the prioritization of human comfort, the air in the building is conditioned during the summer.³⁷ As seen in Figure 7, the doorways are not perfectly sealed, and they are also regularly opened because of the Mission's high visitation rates. In the winter, the building is unheated, with air exchange through the doorway.

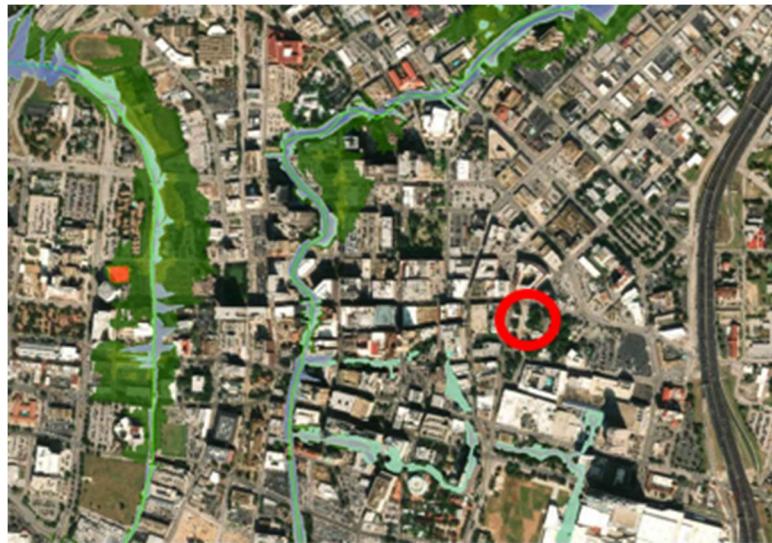
Figure 8: Red circle indicates the location of the structure, the green lines indicate risk map streams, blue highlights indicate flood depth (1% annual chance), green highlighted sections indicate 30-year risk of flooding.⁴²

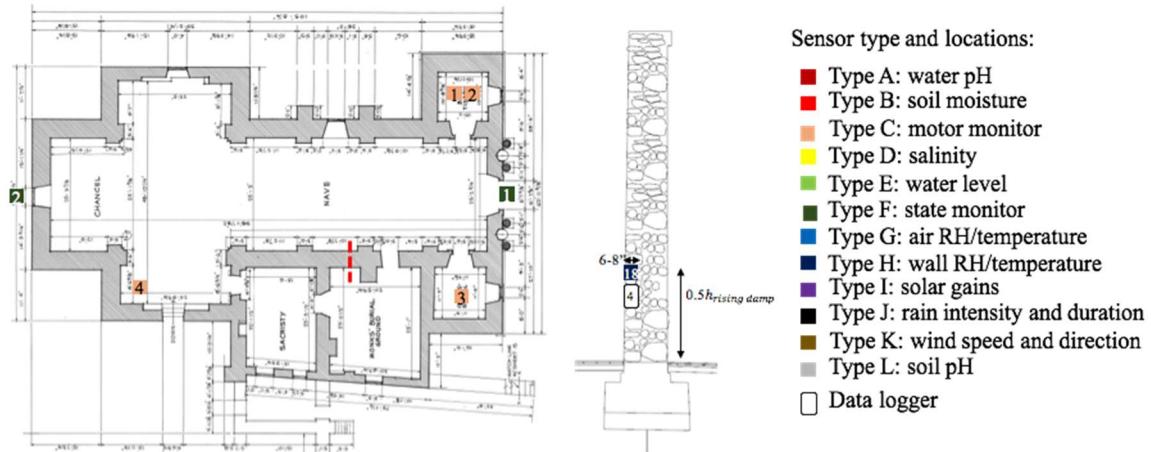
Figure 11: Map indicating the locations of sensors in locations aside from the south wall. Color indicates typology and the number is incremental within the typology.

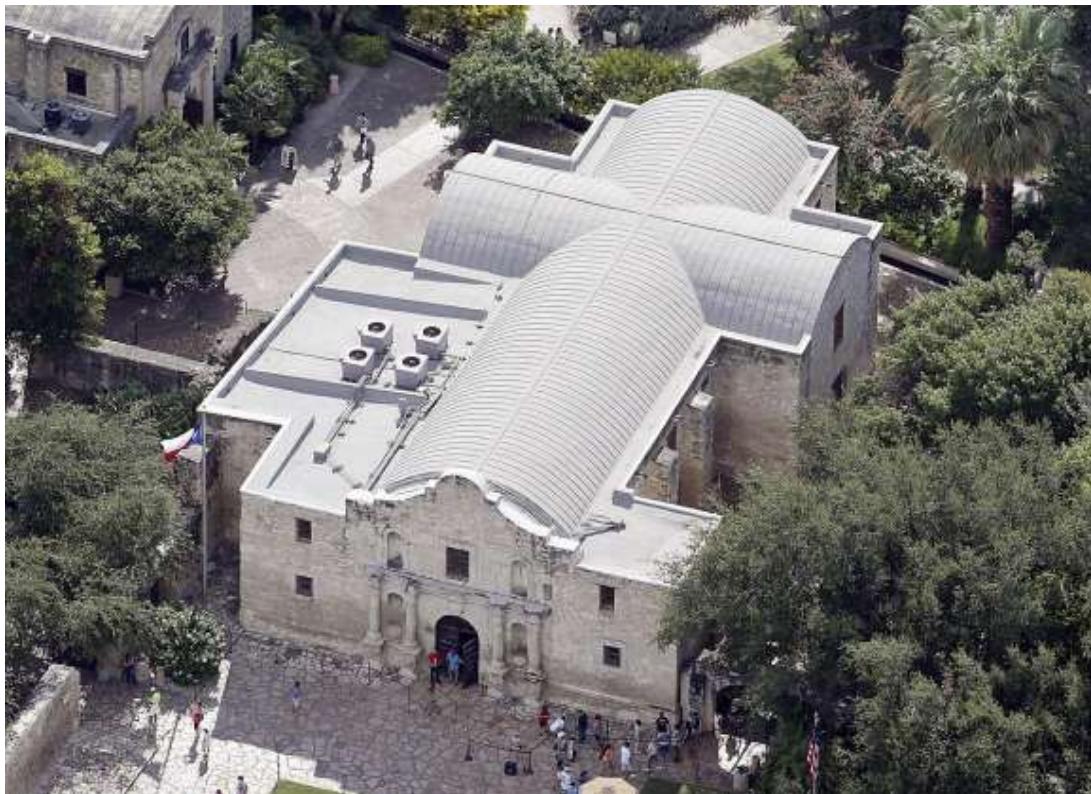
Figure III.3: 2015 Image showing the contemporary lead and concrete roof³
